# Erosive Corrosive Wear Performance of Single Layer CrN Coatings on AISI 304 Stainless Steel in Sea Water Centrifugal Pumps using Steady State Analysis

**Abstract**— The purpose of present study was to investigate the erosive corrosive wear behavior of single layer (CrN) coatings on AISI 304 Stainless Steel samples with varying coating thickness (0-200 nm) in the range of 50 nm. The slurry jet erosive test was conducted on Slurry Jet Erosion Tester in saline slurry (3.5wt% salt) under the different working conditions with varying impact velocity (10-25 m/s), impingement angle (30°-75°) and erodent discharge (160-280 gm/min). Steady state analysis was applied to find optimum parameters for the minimization of erosion rate of various coated and uncoated samples. The finding of steady state condition tests indicated that the erosion rate increased with the increase in impact velocity and erodent discharge but decreased with the increase in coating thickness. The results also indicated that erodent discharge was the most significant factor, followed by impingement angle and impact velocity for the CrN coated samples. The SEM characterization of the eroded samples was carried out in o

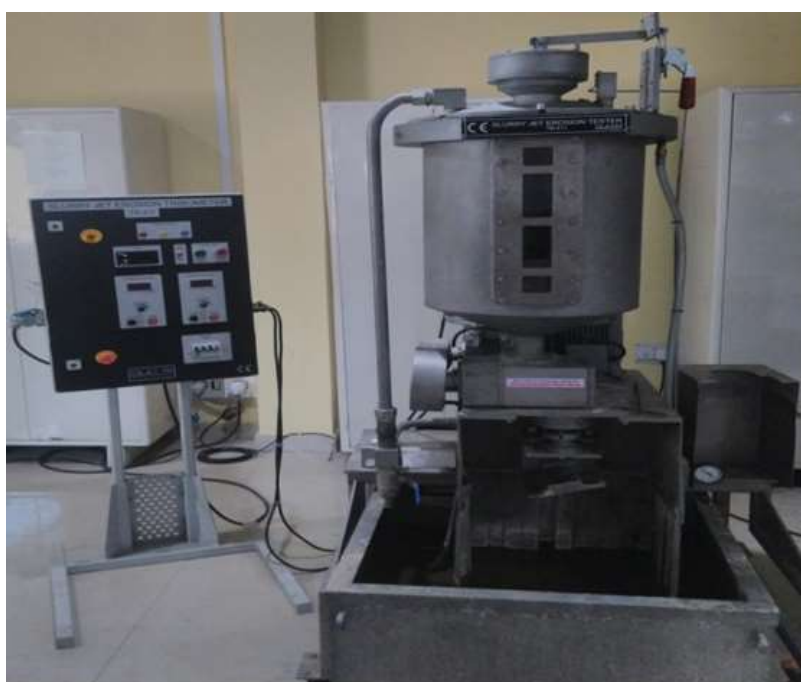
Fig.2: Test setup of Slurry Jet Erosion Tester

The slurry erosion behavior of single layer CrN coated and uncoated samples was evaluated using a Slurry Jet Erosion Tester (Model TR411, Ducom, India) (Figure. 2). For this test, slurry was prepared by mixing sand particles and water and taken in the hopper. Square samples of dimensions  $25 \times 25 \text{ mm}$  was placed in the sample holder. Samples were eroded by flow of erodent discharge through a nozzle of 4 mm diameter. Impingement angles were changed by adjusting the sample holder at different angles ( $30^\circ$ ,  $45^\circ$ ,  $60^\circ$  and  $75^\circ$ ). The strike was applied for 10 min. The weight loss was determined by the weighing the sample before and after the slurry erosion test. The slurry erosion rate was calculated by dividing weight loss of samples with the time taken to perform an experiment i.e. 10min.

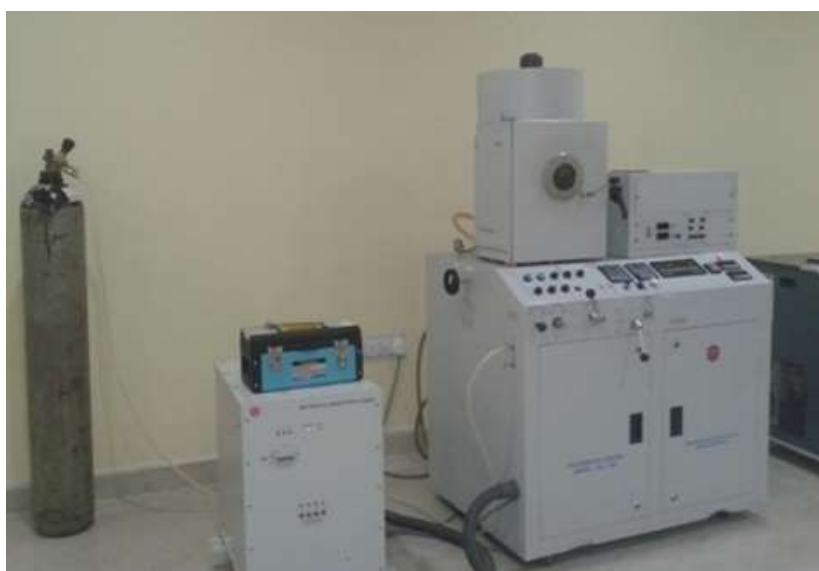
Fig.1: Thermal/E-beam PVD Coating Unit

A thermal Vapor deposition process (inside a high temperature Vacuum Box Coater -Model BC-300, Hind

High Vacuum Co. (P) Ltd. Bangalore, India) (Figure.1) was used to fabricate single layer (chromium nitride) coated AISI 304 Stainless Steel with varying coatings thickness (50nm, 100nm, 150nm and 200nm). In this coating process, a sample of AISI 304 Stainless Steel was first positioned in the sample holder. Then a tungsten filament was used to hold the pellet of pure chromium. A high vacuum of  $10^{-3}$  bar was created inside the chamber and current (50-75 A, 12 V) was supplied to the tungsten filament to evaporate pure chromium. Then, nitrogen gas was allowed to flow in the chamber which reacted with the evaporated chromium and a layer of chromium nitride was deposited on the surface of the AISI 304 Stainless Steel. Coating thickness was maintained as 50nm, 100nm, 150nm and 200nm. Parameters for CrN coating were taken as coating rate-  $0.1 \text{ \AA/sec}$ , coating thickness-200nm, Vacuum Chamber temperature-2000°C, Vacuum Pressure-  $1.2 \times 10^{-6}$  bar, Nitrogen flow rate- 50cc/min, Voltage-12V, Current- 39 Ampere.
